#### **IPEX-2 Post Flight Ground Test**

Prepared By
Gary Ortiz
for
MICRODYNAMICS WORKSHOP
June 23, 1999

## Test Configuration for 1- Bay and 9-Bay Truss

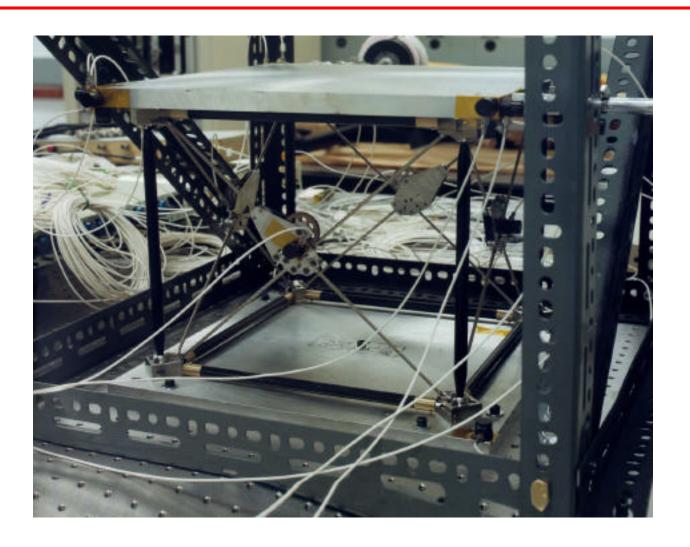
## 1-Bay Test Configuration

• Structure excitation was provided by two 5 lb electro-static shakers

- Single Bay was instrumented to measure 27 degrees of freedom
- Truss was instrumented to measure 60 degrees of freedom

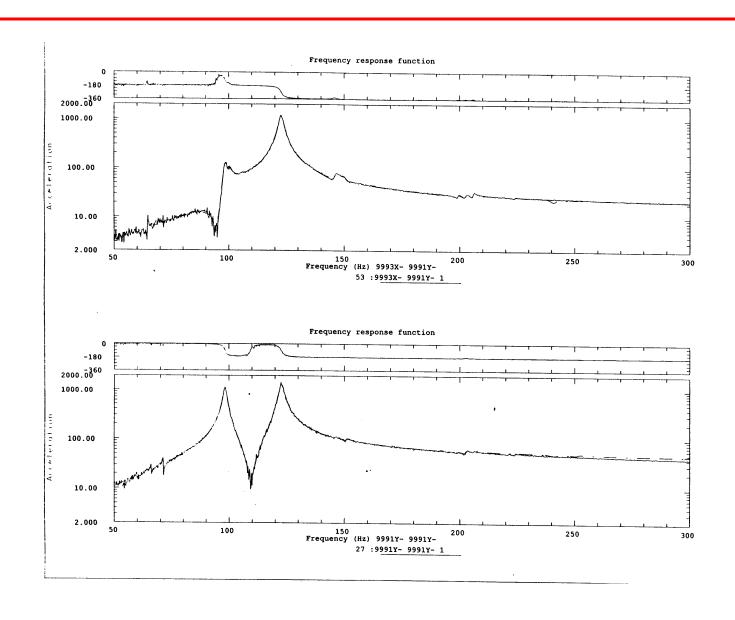
### 1-Bay Data Curve Fit

Mode Shape Description for 1-Bay Burst Random Tests							
Mode	Freq. (Hz)	Damp (%)	Mode Shape Description				
1	64.5	0.2	Breathing Mode				
2	66.1	0.2	Breathing Mode				
3	71.3	0.1	Breathing Mode				
4	98.3	0.8	1st Bending Mode				
5	100.2	0.8	2nd Bending Mode				
6	122.8	8.0	Torsion Mode

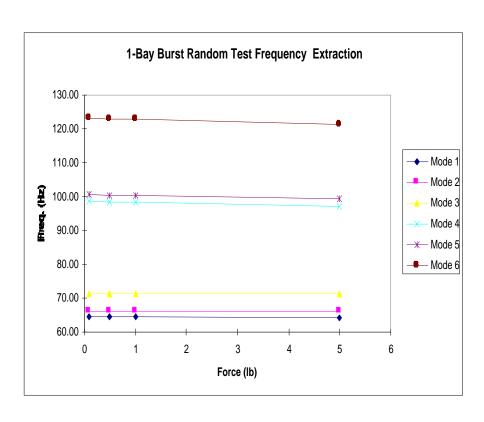
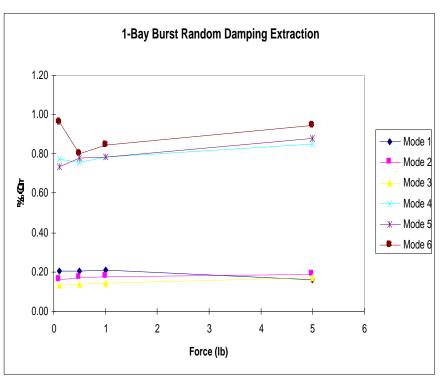
## 1-Bay Burst Random Test Modal Properties vs. Force Input

Modal Frequency

**Modal Damping**

- As input level increases, modal frequencies decrease as modal damping increases; structure appears to become softer due to slipping joints.
- Stepped Sine tests indicated both the 1-bay structure and 9-bay truss are highly linear at low force levels.
- Thermal loading produced structural snapping.
- It was verified that flight instrumentation was reliable based on calibration tests.
- Due to dissimilar boundary conditions, modes from test are lower compared to on orbit and the finite element model predictions.

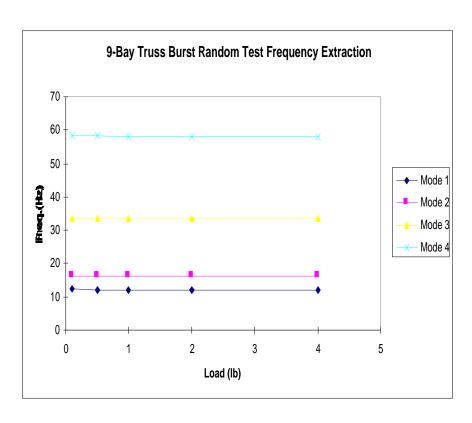
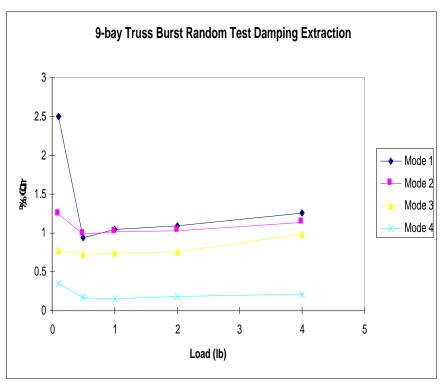
## 9-Bay Truss Burst Random Test Modal Properties vs. Force Input

Modal Frequency

Modal Damping

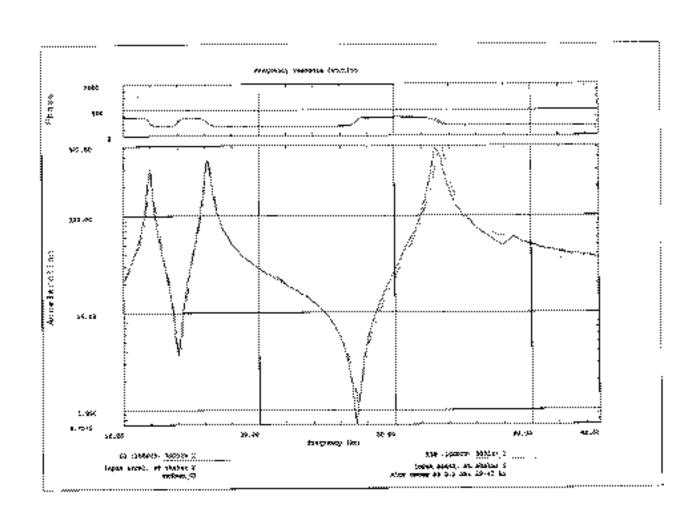
## 9-Bay Truss Stepped Up vs. Stepped Down

Ascending and Descending Stepped-Sine tests address global linearity of the truss.

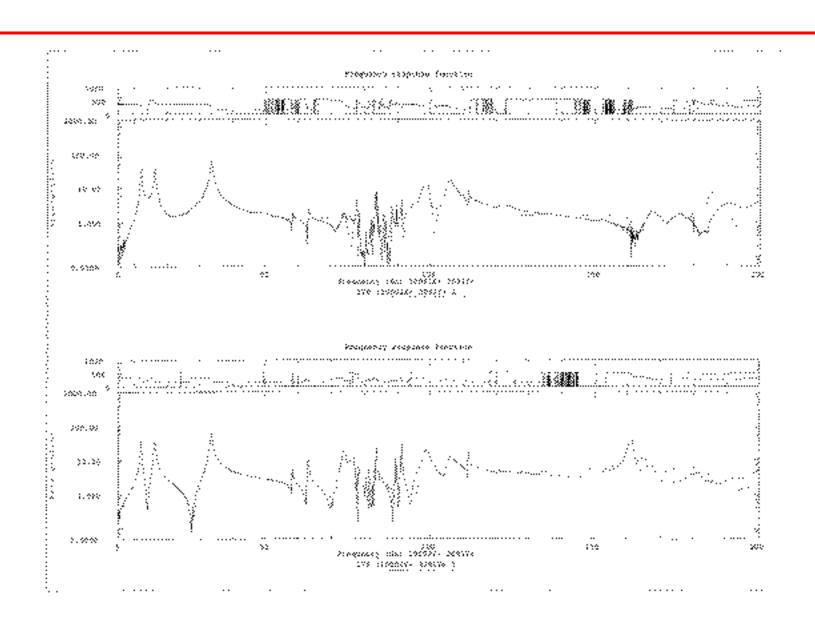
#### 9-Bay Truss Data Curve Fit

Mode	Freq (Hz)	Damp (%)	Mode Shape Description
1	12.15	0.94	Transverse Shearing
2	16.31	1.00	Transverse Shearing
3	33,63	0.82	Torsion
4	58.18	0.14	Breathing Mode (Fitting)

•		
	Test	FEM	On Orbit		
Mode#	Freq.	Freq.	Freg.	Mode shape	
	(Hz)	(Hz)	(Hz.)		
1	12.15	16.30	1	Shear	
2	16.31	19.90	19.90	Shear	
3	33.63	29.78	37.92	Torsion	
4	58.18	54.70	64.91	Breathing (fitting)

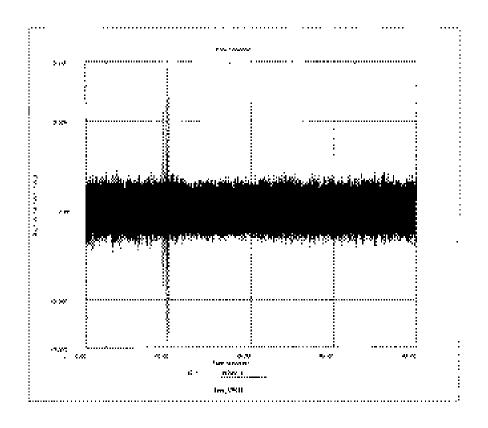
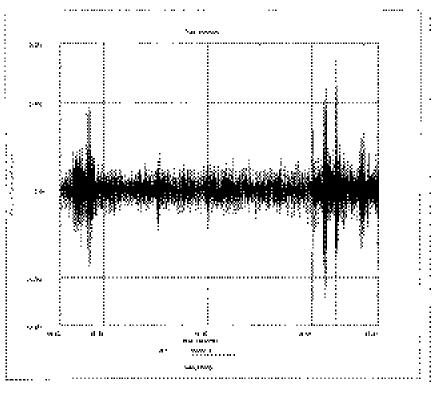
## 9-Bay Truss Thermal Snapping

Provided opportunity to investigate structural snapping by obtaining time histories from thermal loading.

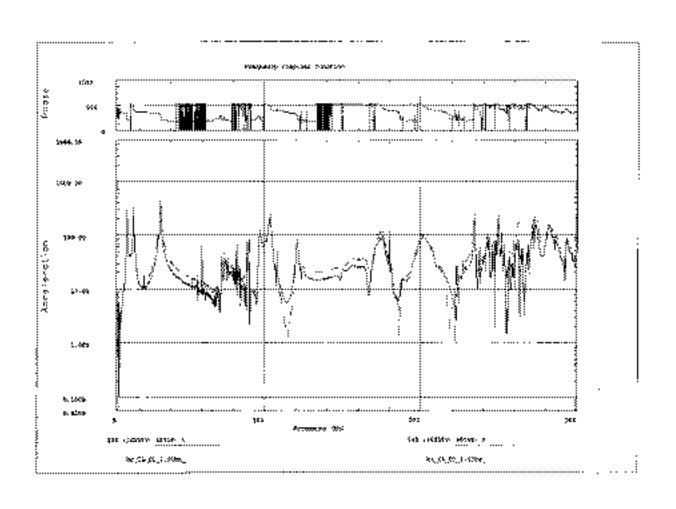
## 9-Bay Truss Collocated Flight and Test Accelerometers

• Collocated test and flight accelerometers for flight electronics calibration during tests.
